Field Notes Bulletin

E-FSA: Possible Nuisance Conditions With E-PD and E-PHD Detectors

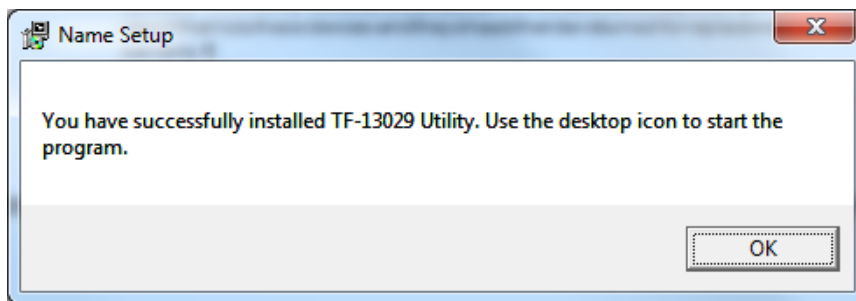
Figure 1: Name Setup dialog

1. Go to www.edwards-signals.com and copy the file TF_13029.zip to your desktop.
2. Unzip the file and run the installer. After successful installation of the TF-13029 utility, the Name Setup dialog displays (Figure 1).
